Improved legsupport attachment on SWING

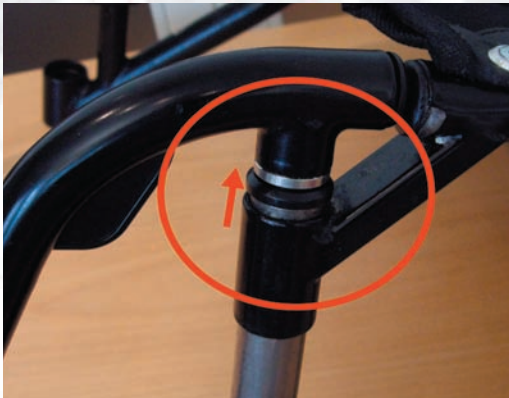
Used with heavy load, the attachment for the legsupport on Panthera Swing could come loose slightly. See upper image..

There is no risk for the attachment to come loose completely, just a small gap will occur between the vertical chassi tube's (unpainted) upper limit, and the chassi socket. The function of the swing-away leg-rest could get less accurate.

There is no risk of using a wheelchair with this defect..

Make sure to check this part at service or re-conditioning.

If you have a wheelchair with this defect, you will get you a new reinforced chassi through warranty for free.

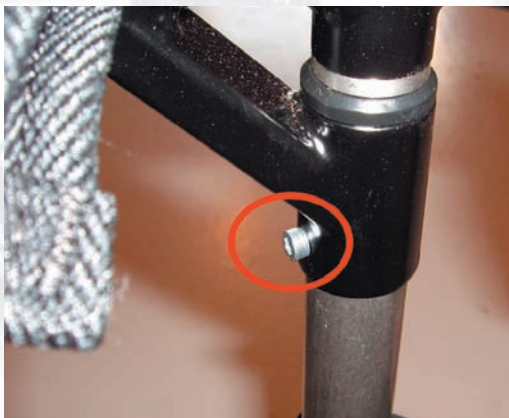
What we have done is to add two slits on the vertical tube to make it expand against the socket correctly and that the glue gets a good grip. We have also added a stop screw to strengthen the attachment even more. See lower image.
