Castor wheel bolt for Panthera X

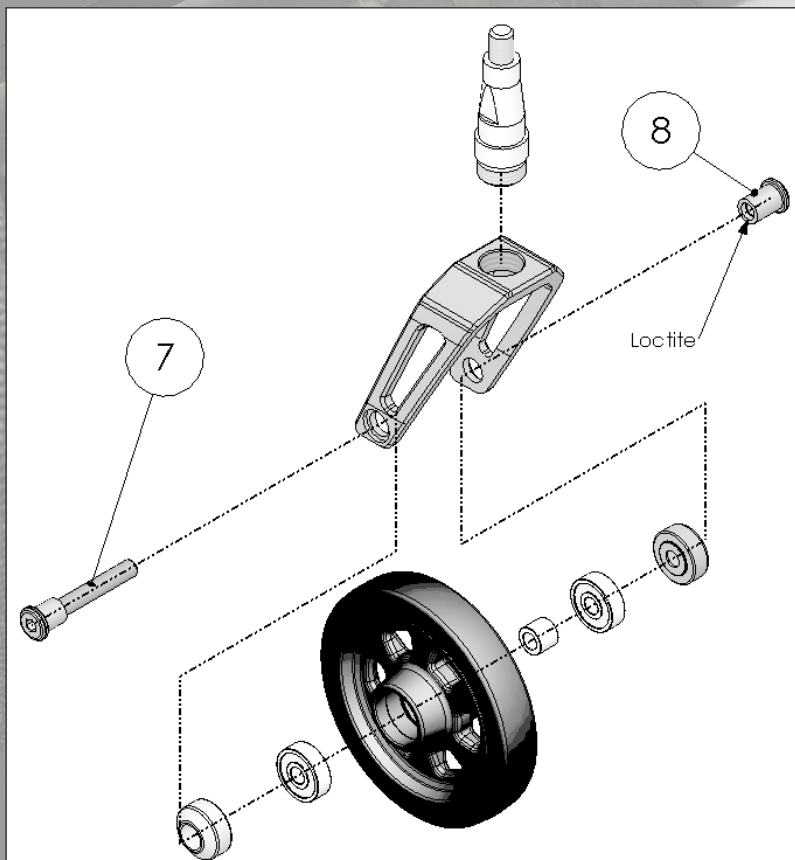
On the first 100 Panthera X delivered, an improper threadlocking (Loctite) has been used on the castor wheel bolt. (pos. 6 och 7)

It has been too strong which mean that the bolt could deform when disassembling the castor wheel, due to the force needed to loosen the bolt.

For those customers that has been affected by this. we offer a new bolt and nut for free. Contact Panthera and we post it without delay.

Pos.	Description	art.no.
6	Bolt fork X	4810132
7	Nut fork X	4810133
