PUSHHANDLE BRACKET BAMBINO

Product information regarding push handle bracket Bambino

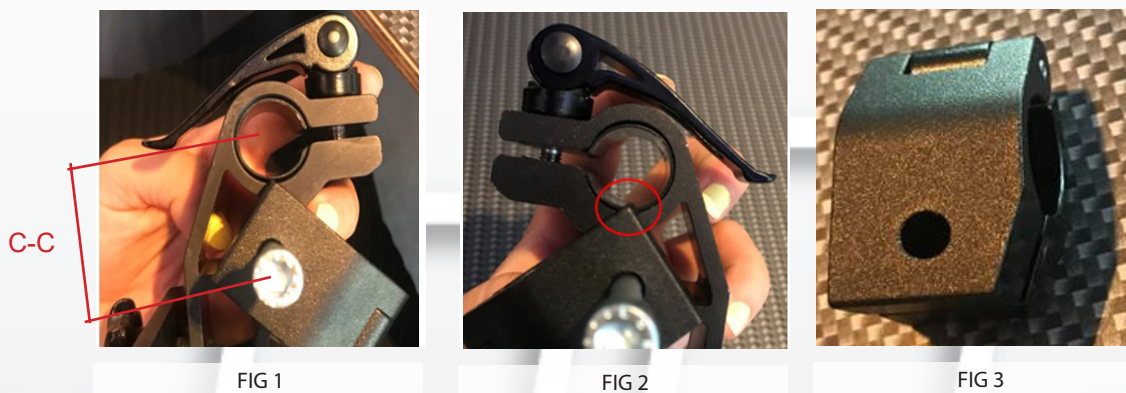
We have received a deviating delivery of push handle attachment for Bambino art.no. 4250021 / 22.

The deviation is caused by the C-C dimension between the holes on the pushhandle attachment (**Fig. 1**) being too small. This results in one corner of the hinge clamp covering a part of the hole where the drive handle is mounted (**Fig. 2**).

To ensure deliveries of wheelchair orders, we have a temporary but technically solid solution with a beveled hinge clamp (**Fig. 3**) for a short period while waiting for a new delivery.

The beveled hinge clamp is compatible with all assemblies.

During reconditioning / service, mounting problems can occur if the beveled hinge clamp and this version of the pushhandle attachment are not held together in the same kit. If you want to replace the pushhandle attachment, please contact us.
