Info sheet 2010-02
2010-03-22

PROCEDURE WITH LEG SUPPORT FOR SWING

Concern chassis delivered before date: 01 Aug 2009.

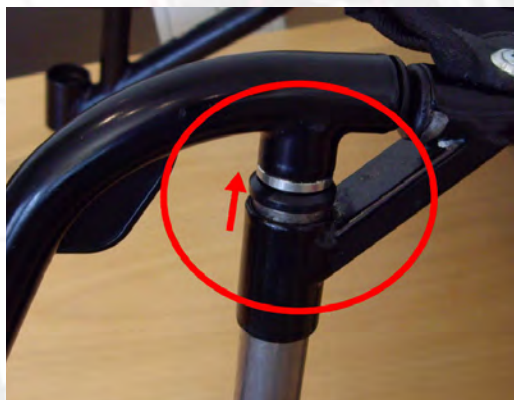
Description of the problem and how we reinforce the chassis today.

During heavy load, the attachment for the leg support on Panthera Swing, delivered before date 01 Aug 2009, could come loose slightly. See upper image.

There is no risk for the attachment to come loose completely, just a small gap will occur between the vertical chassis tube's (unpainted) upper limit and the chassis socket. The function of the swing-away leg rest could get less accurate. There is no risk of using a wheelchair with this defect.

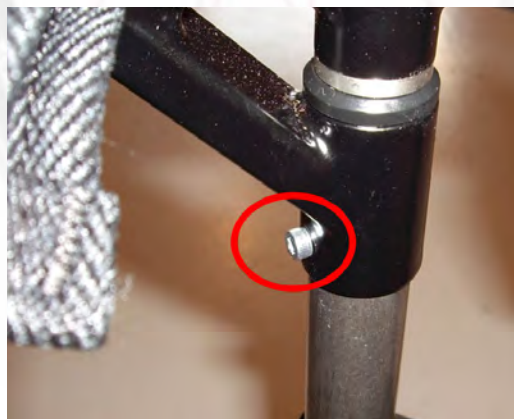
What we have done is to add two slits on the vertical tube to make it expand against the socket correctly and that the glue gets a good grip. We have also added a stop screw to strengthen the attachment even more.

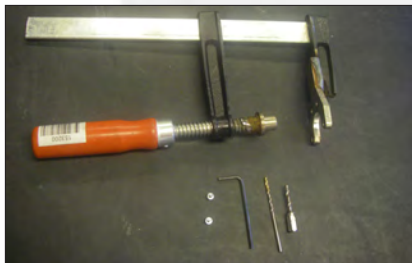
The reinforcement-kit contains:

- 1) A special clamp tool
- 2) A drill 2,4 mm
- 3) A tap for M3
- 4) An allen key
- 5) 2p M3 stop screw.

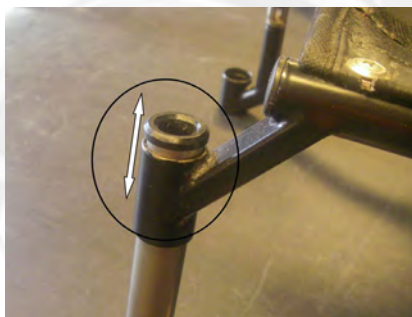
To reinforce the chassis you drill hole by the attachment and thread it for M3, where you put a stop screw.

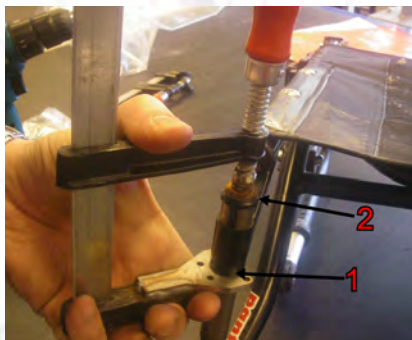
Place the clamp tool on the upper attachment as shown in the image.

See to that the tool is against the surface underneath (1) and steer into the hole on top (2).

Start to turn the clamp to compress the attachment until no gap is visible.

Let the clamp tool remain in place after compression.

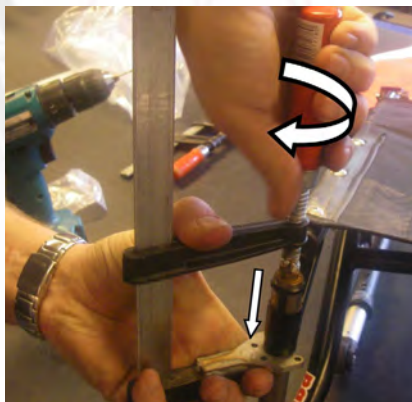
How much force that is needed vary between chairs. Some needs less force than others.

Make a hole with the 2,4 mm drill
The hole should be placed approx. 7 mm from the lower edge and be as close to the center as possible. Try to keep the drilling machine as close to the chassis as possible and at a 90 degree angle to the vertical chassis tube.
Drill through the wall of the tube..

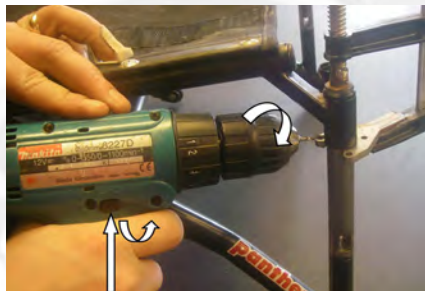
Use the M3 tap in the same hole. Thread clockwise carefully on a very low rpm. Before the tap pass through, stop the machine and set it on reverse by pushing button (3), could vary on different machines. Gently thread anti clockwise until the tap is free.

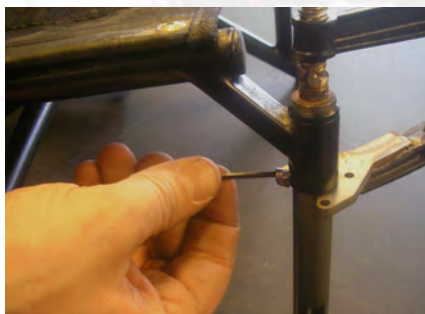
Screw the M3 screw in place. Then remove the clamp tool.

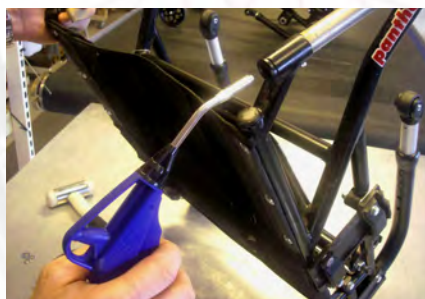
NOTE! Very important!

Carefully remove all chips and dirt that could damage the leg support attachment when it's in use.
