New pull spring for the Panthera X brake

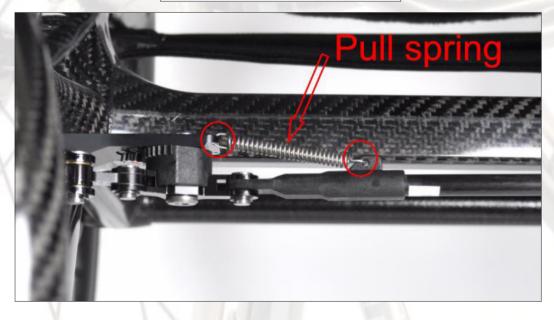
We have detected that a handful of the pull spring (no. 27) on the Panthera X brake, delivered to our customers, do not meet our requirements for quality. It might tear off after a period of use. Therefore, we would like to ask our customers to replace this spring with the new, stronger pull spring.

To replace the spring just disengaged the brake and detach the old spring and then attach the ends of the new spring into the holes, marked with circles in the image.

Engage the brake and disengage it again to see that it springs back properly.
