Info sheet 2020-13 2020-10-05

Bolt to inner casing castor fork X

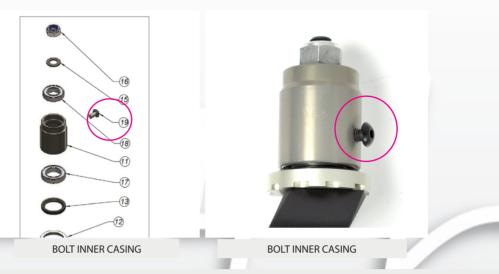
Bolt to inner casing castor fork on X

We have received comments from our customers that the bolt to the inner casing on the Panthera X castor fork can easily be damaged during service or repair. We therefor wish to make an improvement and replace this bolt with a new with a Torx T20 head. The function and mounting is the same but with a reduced risk of damage the bolt when loosing and tightening. We introduce this bolt when mounting on Panthera X wheelchairs and it is possible to order as a sparepart from 1st of October 2020. The price remains the same.

Present bolt:

Replacing bolt:

art.no. 6003408

art.no. 6003409DL
